LAWRENCE
LIVERMORE
NATIONAL
LABORATORY

LLNL-TR-648143

A Visual Description of the Concrete Exterior of the Cactus Crater Containment Structure

October 2013

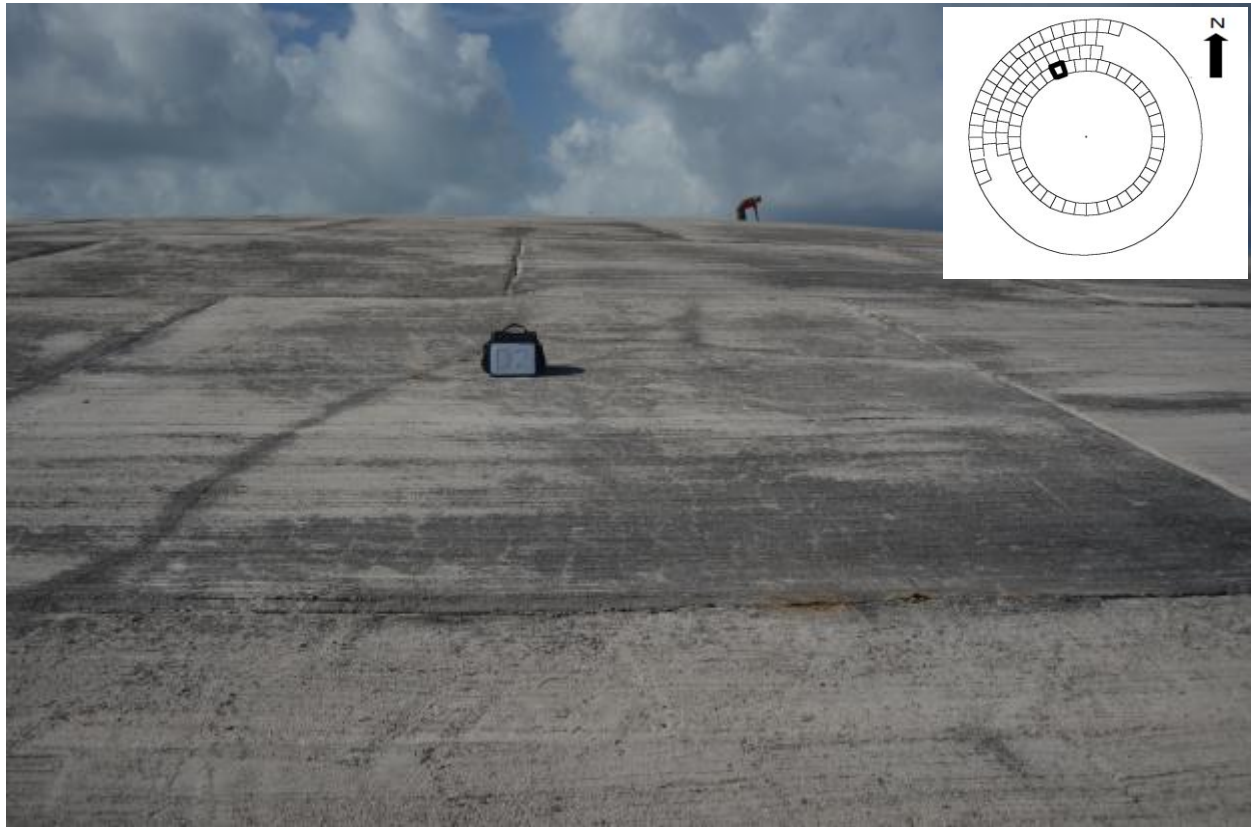
CAP SECTION LOCATION: Panel D3

No significant or obvious interior cracks extending across the top of the panel. The upper portion of the panel has a rough and weathered appearance. Rooting vegetation removed from along the panel seams. Some spalling/cracking of concrete observed in the upper left-hand corner of the panel with some indication that some post-construction work was conducted in an apparent attempt to repair the spall.

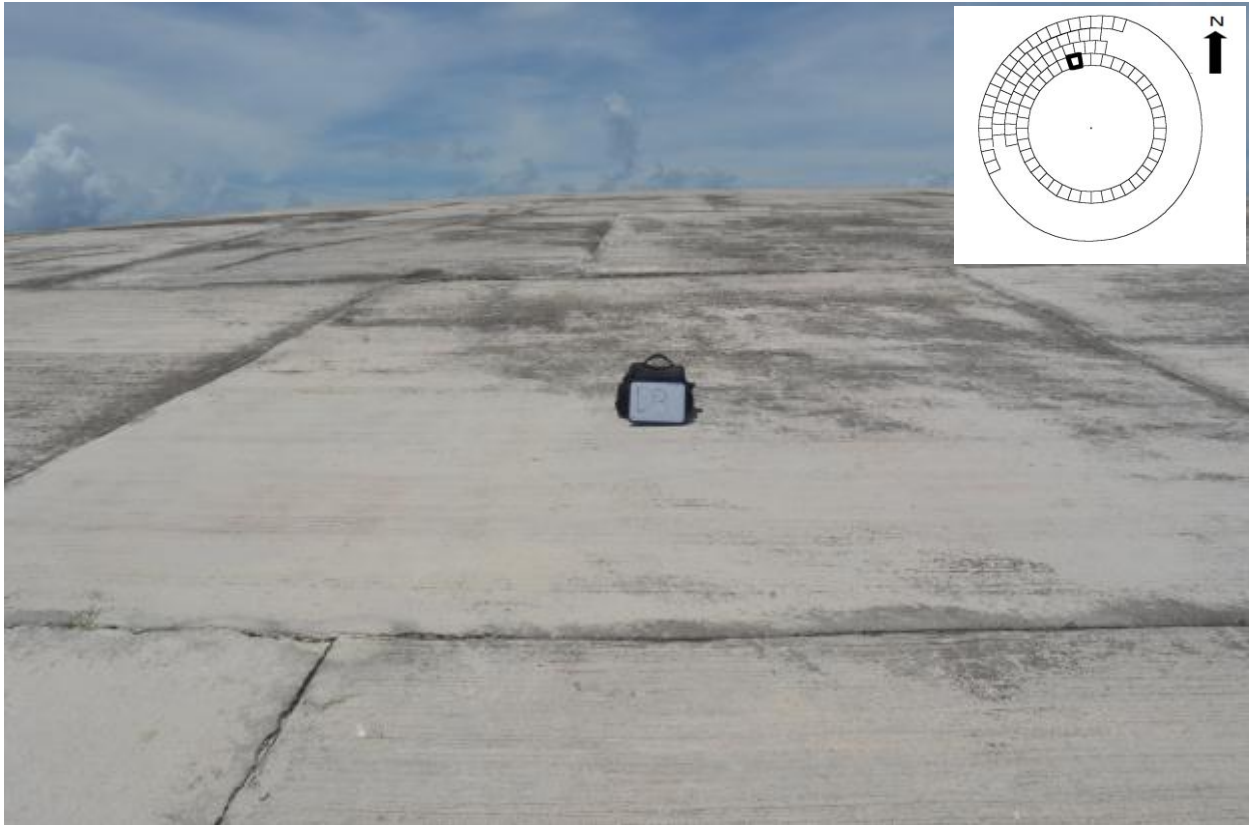
CAP SECTION LOCATION: Panel D4

No significant or obvious interior cracks extending across the top of the panel. Rooting vegetation removed from along the panel seams. Panel contains a vertical elevation benchmark.

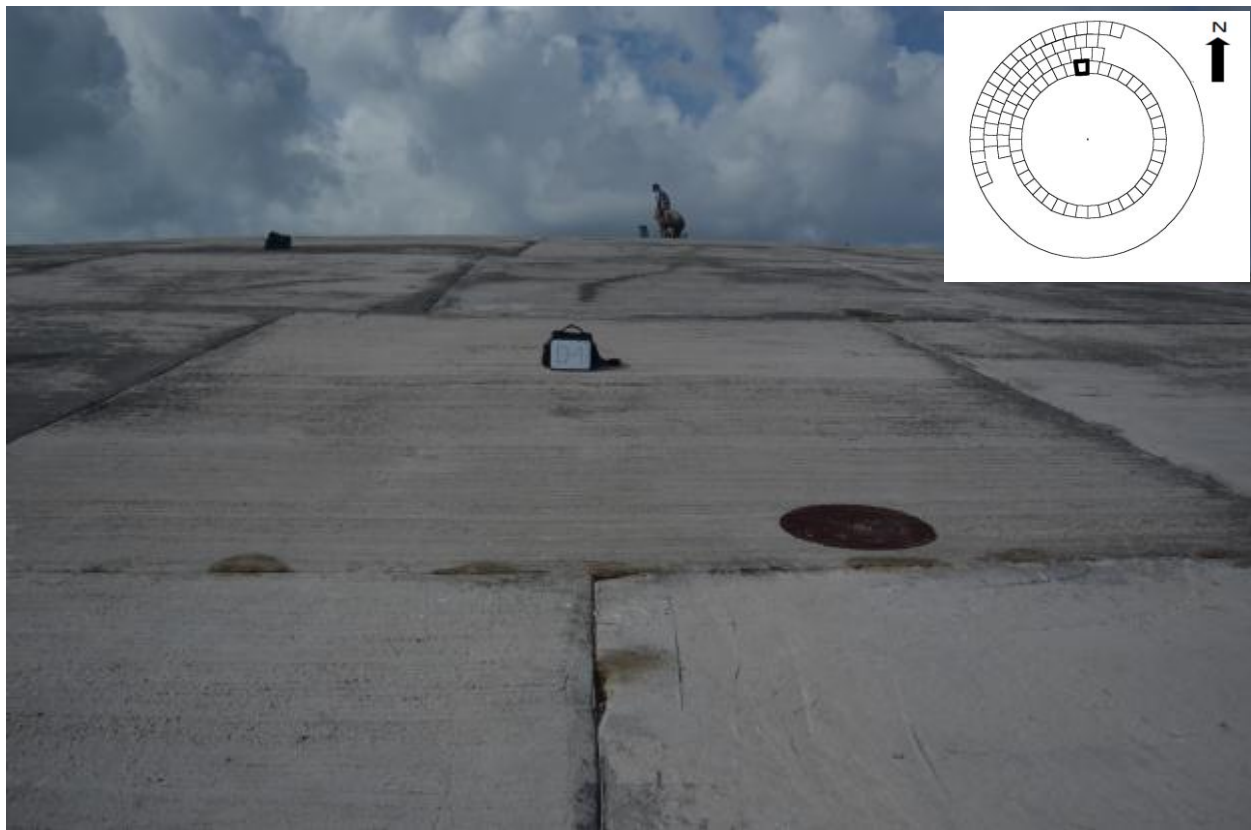
CAP SECTION LOCATION: Panel D5

No significant or obvious interior cracks extending across the top of the panel. The panel has a rough and weathered appearance. Some spalling/cracking of concrete observed in the lower right-hand corner of the panel. Rooting vegetation removed from along the panel seams. Panel contains a filled concrete bore-hole (CD-1) from the 1980 NAS investigation.

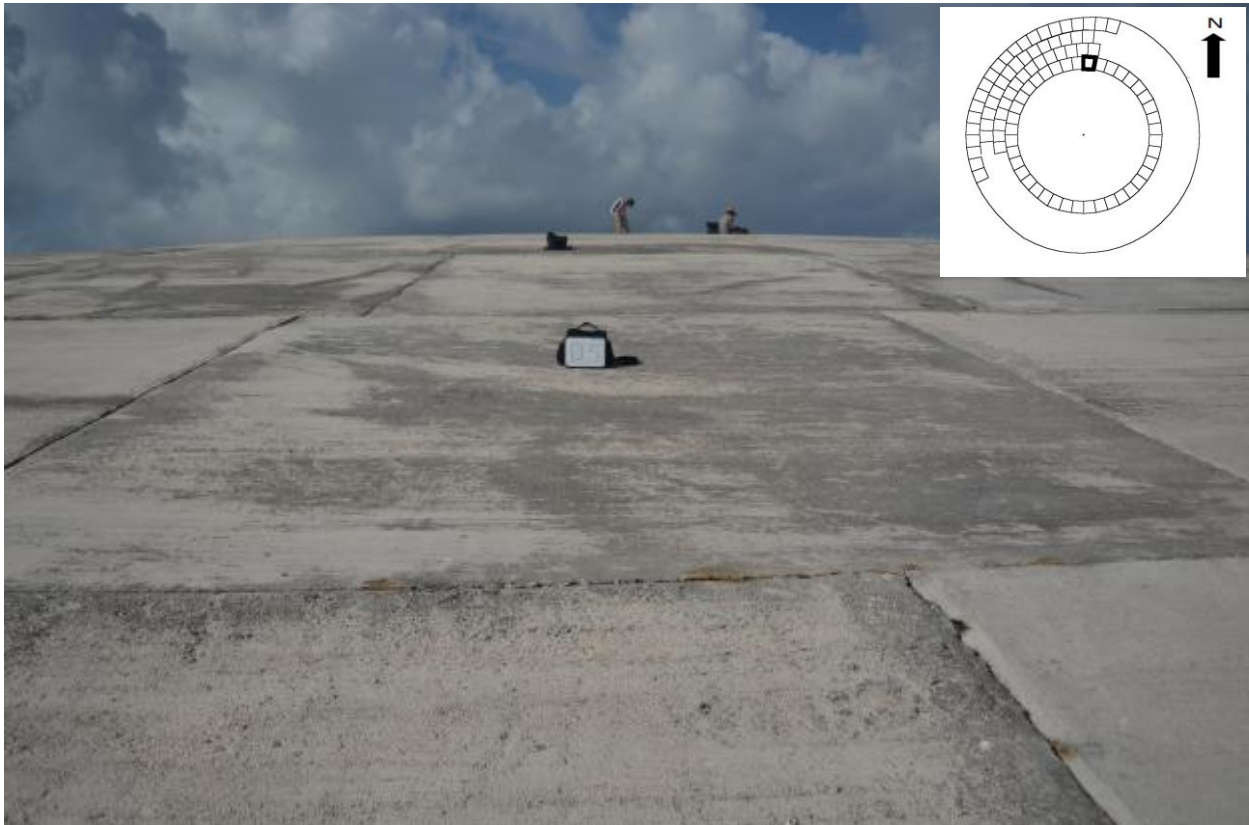
CAP SECTION LOCATION: Panel D6

A surface crack observed extending across the segment at mid-point up the panel. Rooting vegetation removed from along the panel seams.

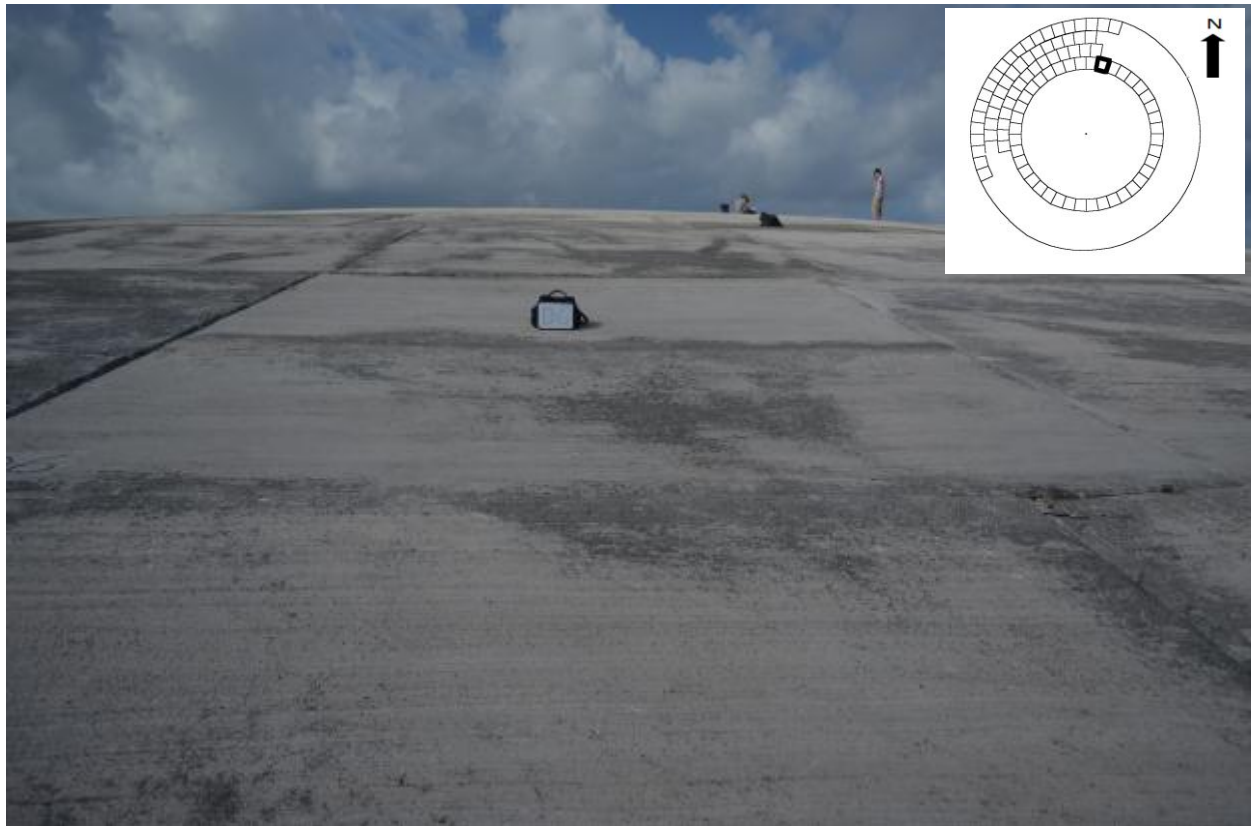
CAP SECTION LOCATION: Panel D7

No significant or obvious interior cracks extending across the top of the panel. The panel has a rough and weathered appearance. Rooting vegetation removed from along the panel seams.

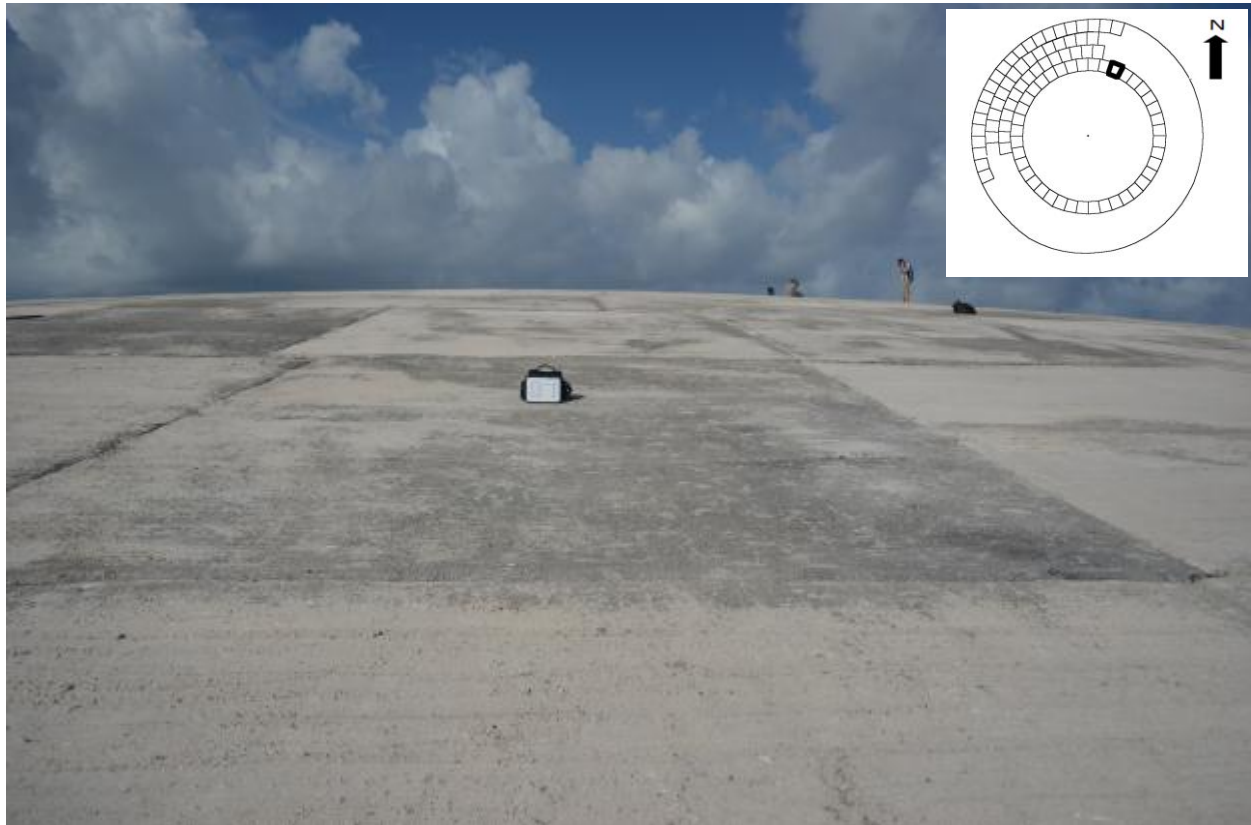
CAP SECTION LOCATION: Panel D8

No significant or obvious interior cracks extending across the top of the panel. The lower left side of the panel has a weathered appearance. Rooting vegetation removed from along the panel seams.

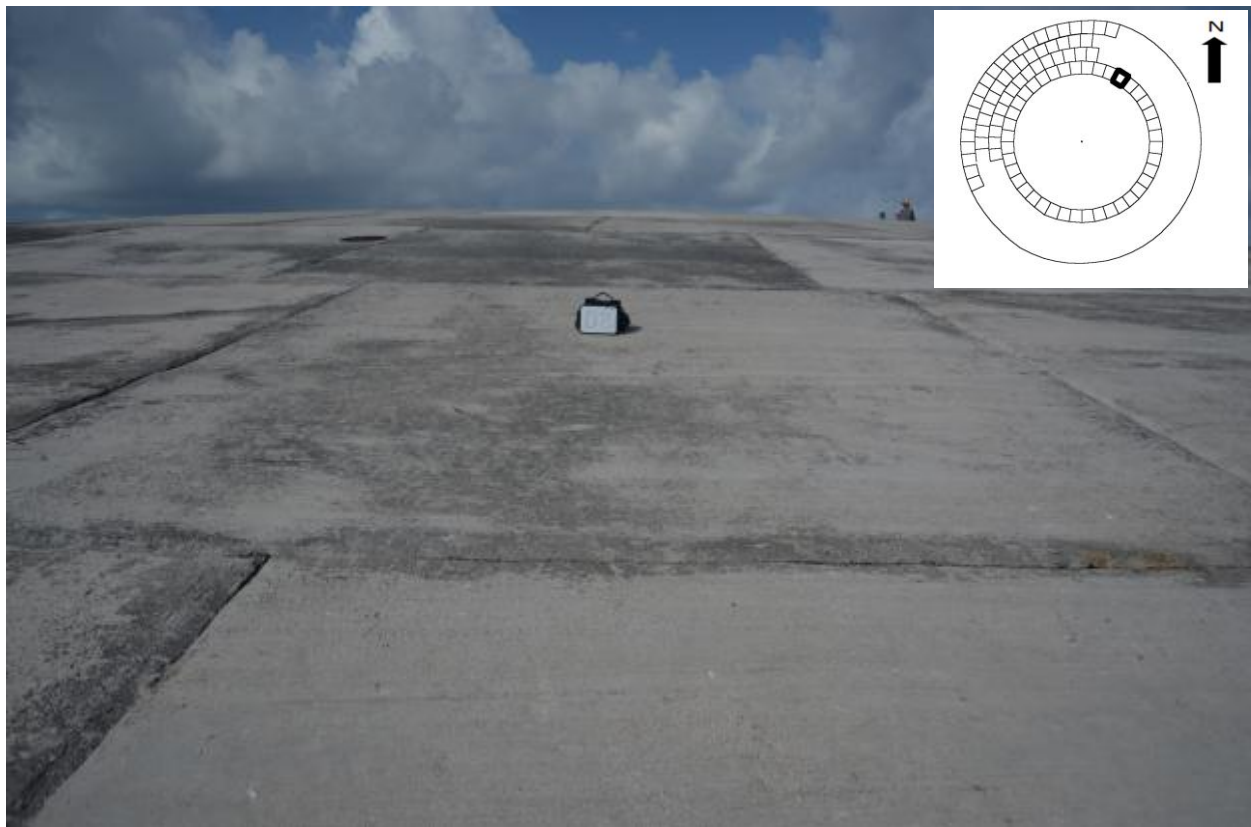
CAP SECTION LOCATION: Panel D9

The panel has a rough and weathered appearance. Rooting vegetation removed from along the panel seams. A surface crack observed extending from the bottom seam branching into fork at about the mid-point up the panel out to the left and right edges.

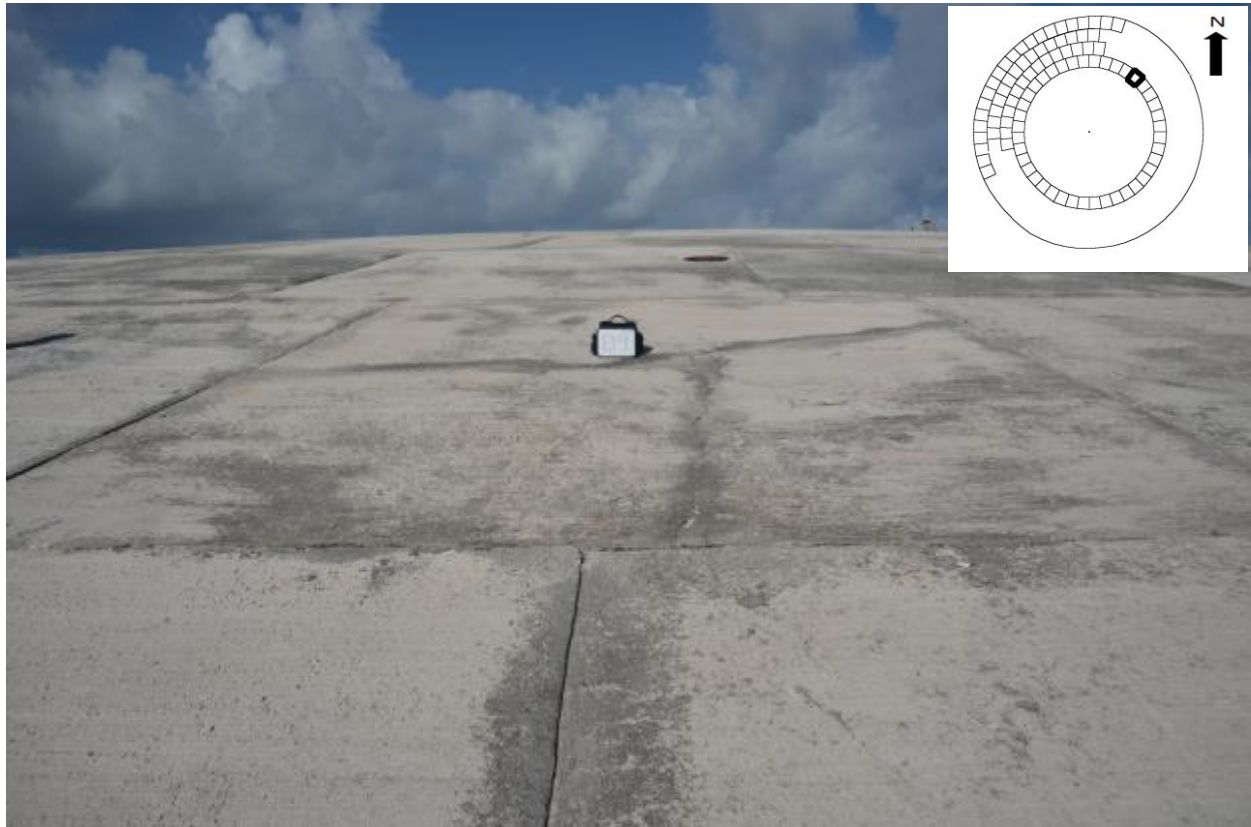
CAP SECTION LOCATION: Panel D10

No significant or obvious interior cracks extending across the top of the panel. The panel has a rough and weathered appearance. Rooting vegetation removed from along the panel seams. Some minor spalling/cracking of concrete observed along the right side of the bottom seam.

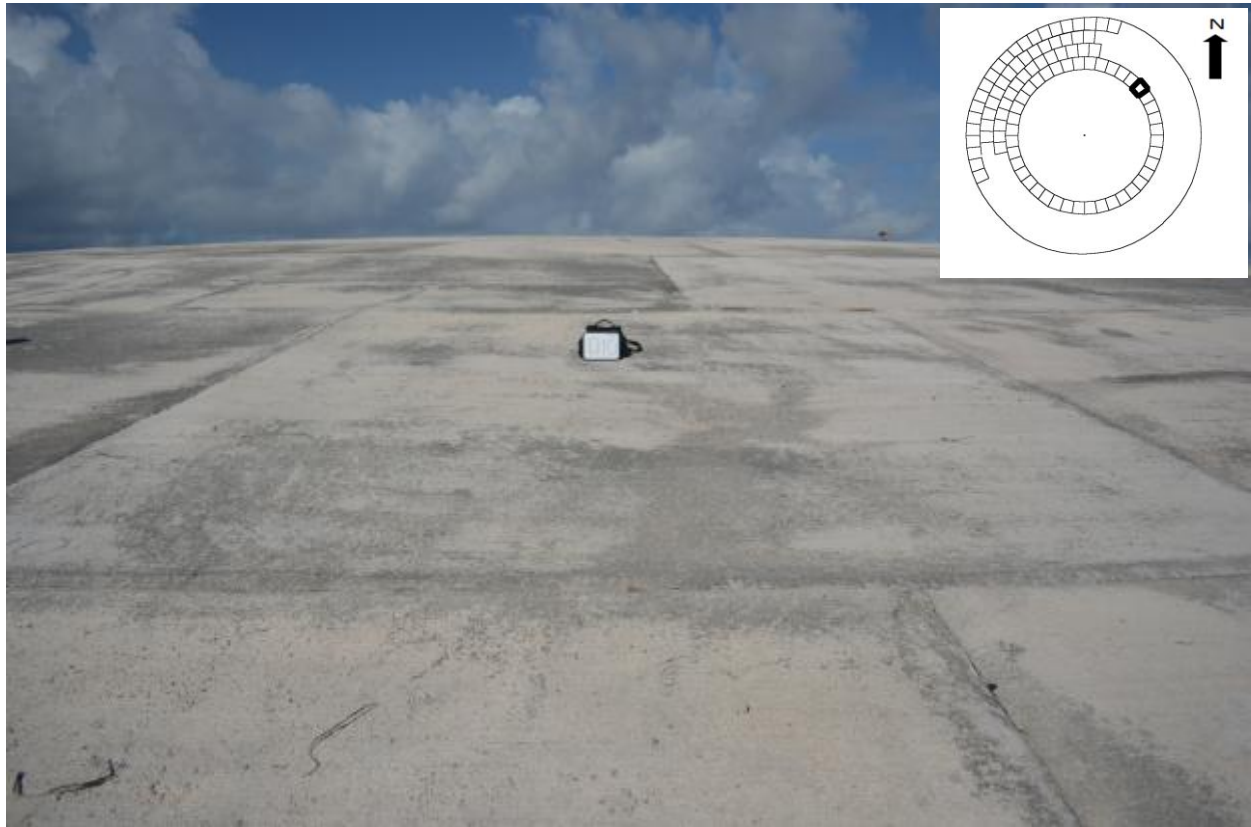
CAP SECTION LOCATION: Panel D11

No significant or obvious interior cracks extending across the top of the panel. The panel has a rough and weathered appearance. Rooting vegetation removed from along the panel seams.

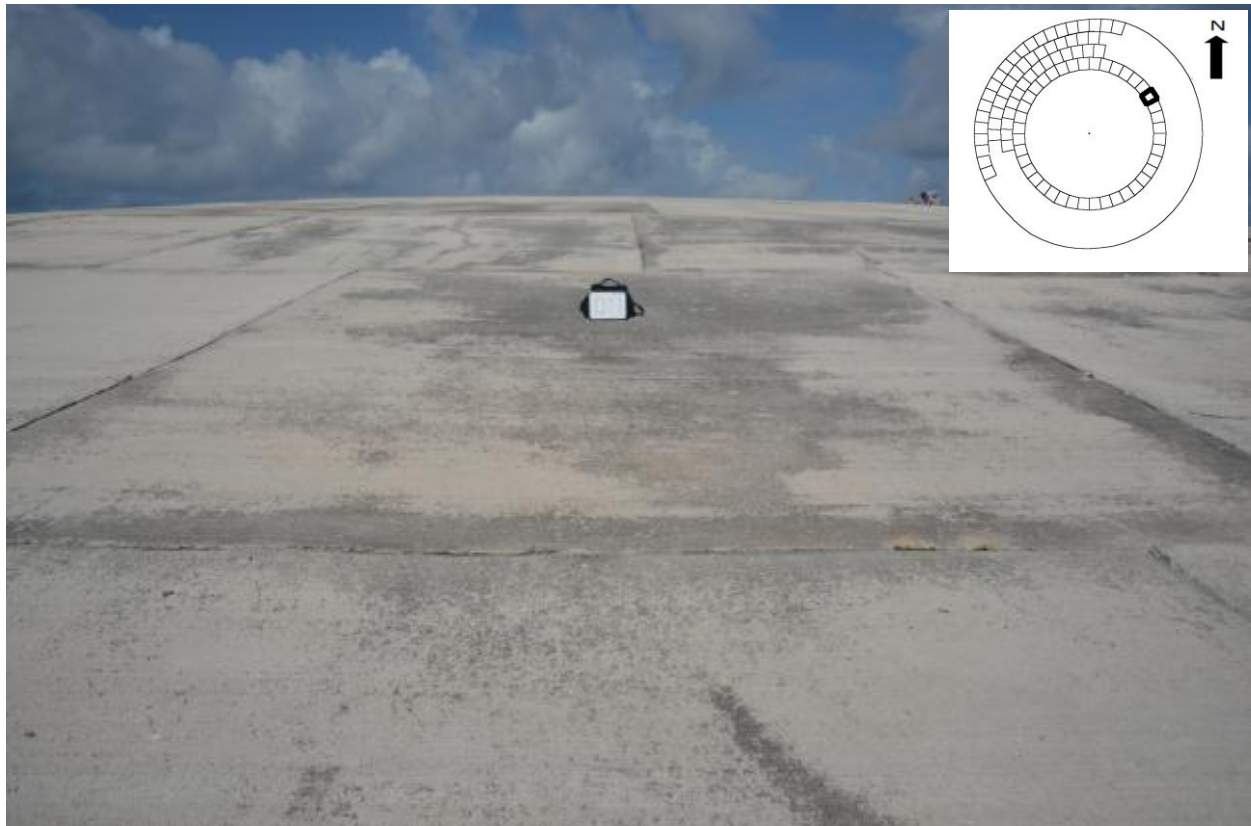
CAP SECTION LOCATION: Panel D12

No obvious interior cracks extending across the top of the panel. Some spalling/cracking of concrete observed in the lower right-hand corner of the panel.

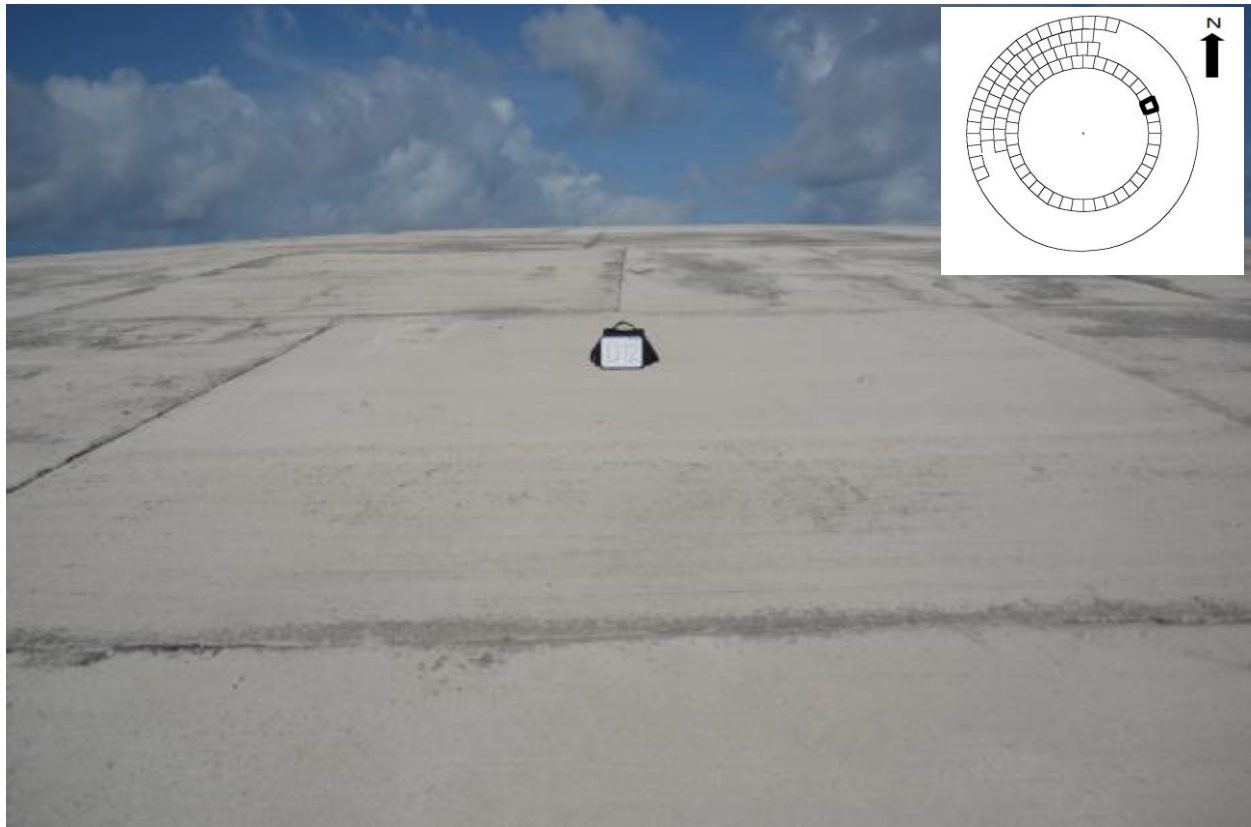
CAP SECTION LOCATION: Panel D13

The panel has a rough and weathered appearance. Surface crack observed extending up from the bottom seam on top edge adjacent to corner intersection E10/E11.

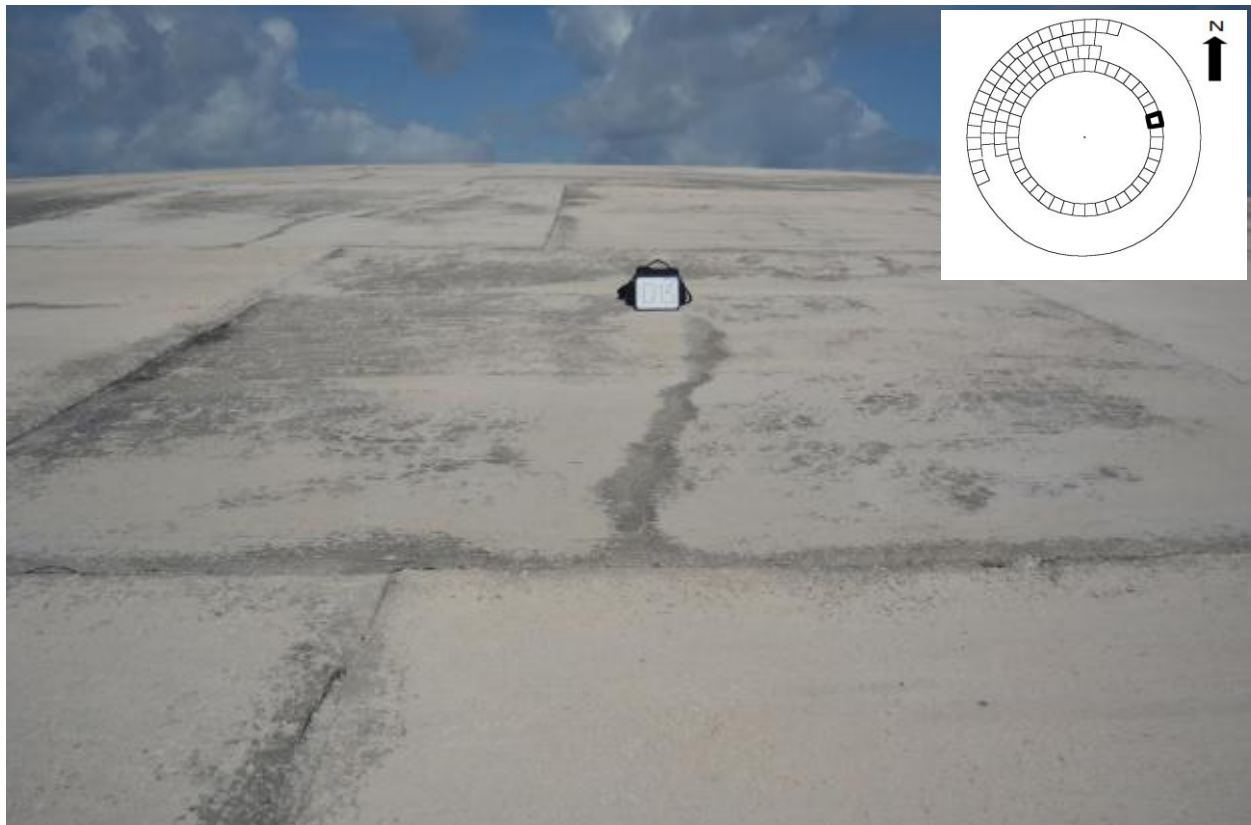
CAP SECTION LOCATION: Panel D14

The panel has a rough and weathered appearance. A surface crack observed extending up from bottom seam adjacent to the corner intersection C17/C18. Panel contains a vertical elevation benchmark.

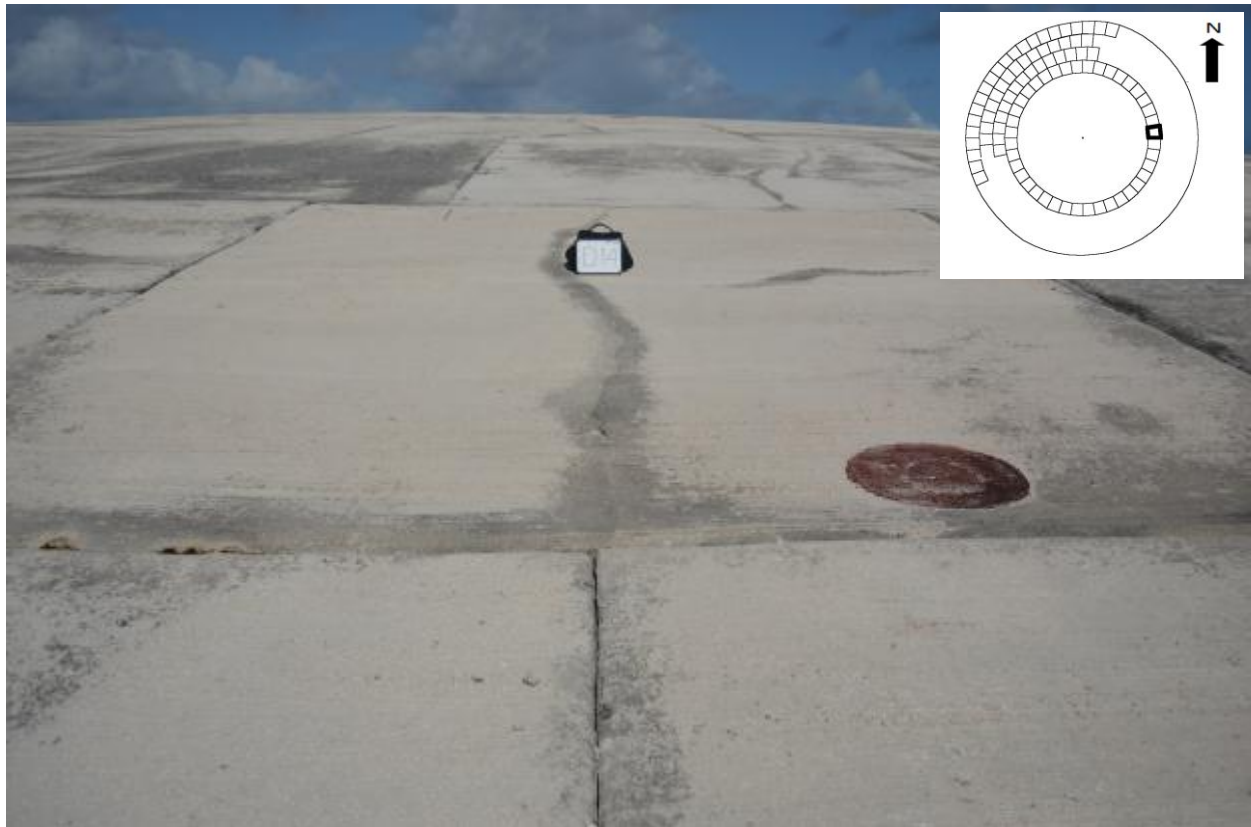
CAP SECTION LOCATION: Panel D15

This panel contains the most severe crack of any segment on the dome. The crack width exceeds several millimeters in some areas, and runs left to right at about a mid-point up the panel as well as up and down the panel from an intersection point in the middle. The crack contained chipped 'spalled' edges. Panel is listed as a priority for any repair work.

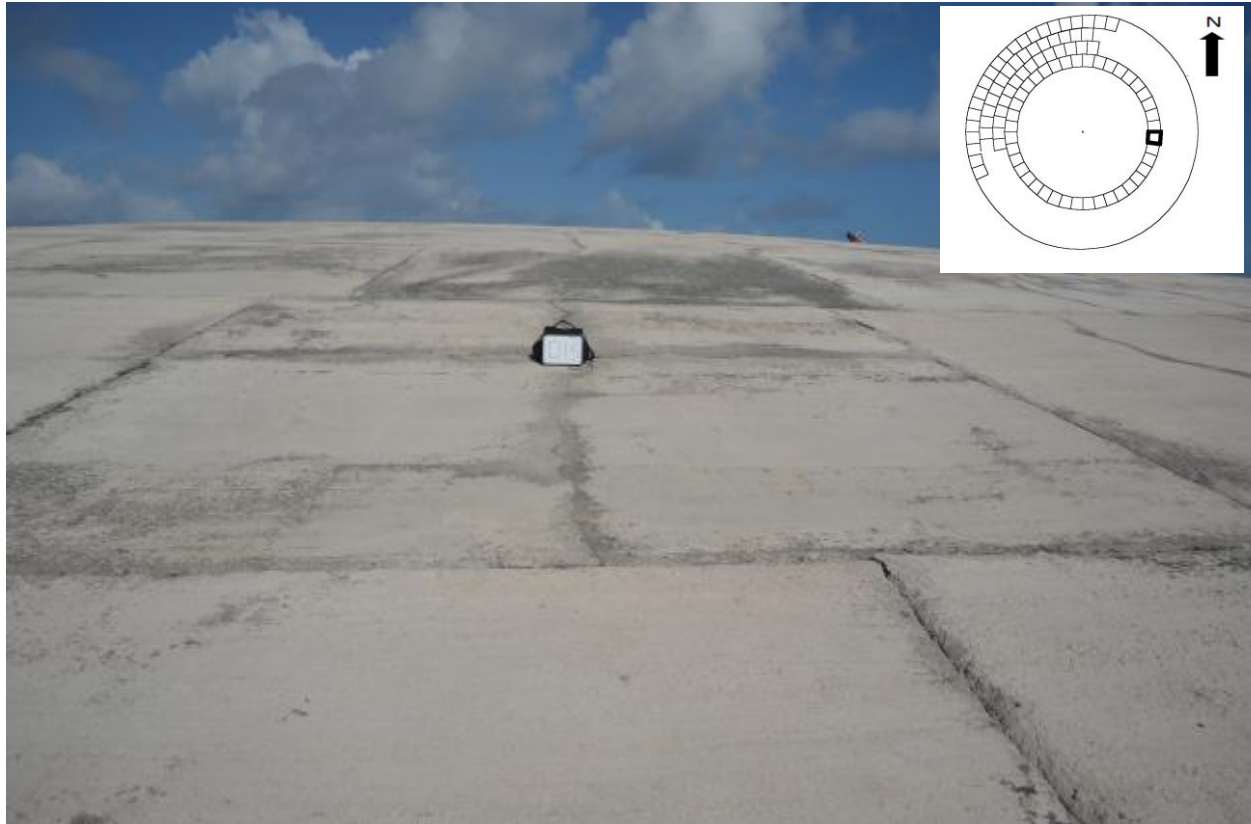
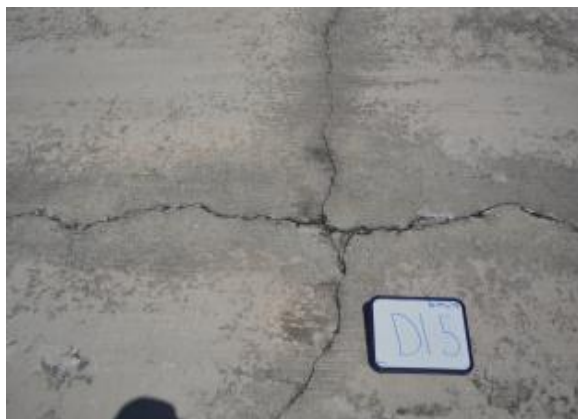
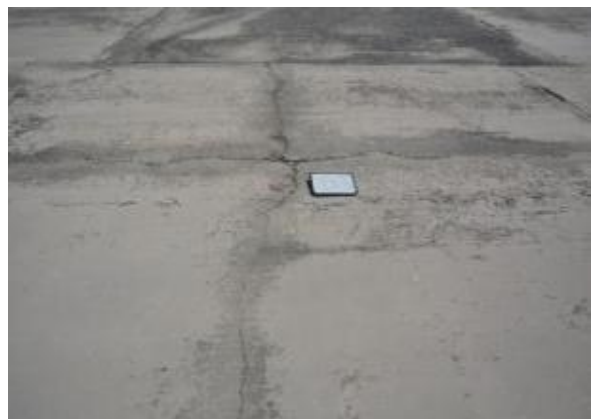
CAP SECTION LOCATION: Panel D16

No obvious interior cracks extending across the top of the panel. Some spalling/cracking of concrete observed along the lower seam on both the left and right sides of the panel.

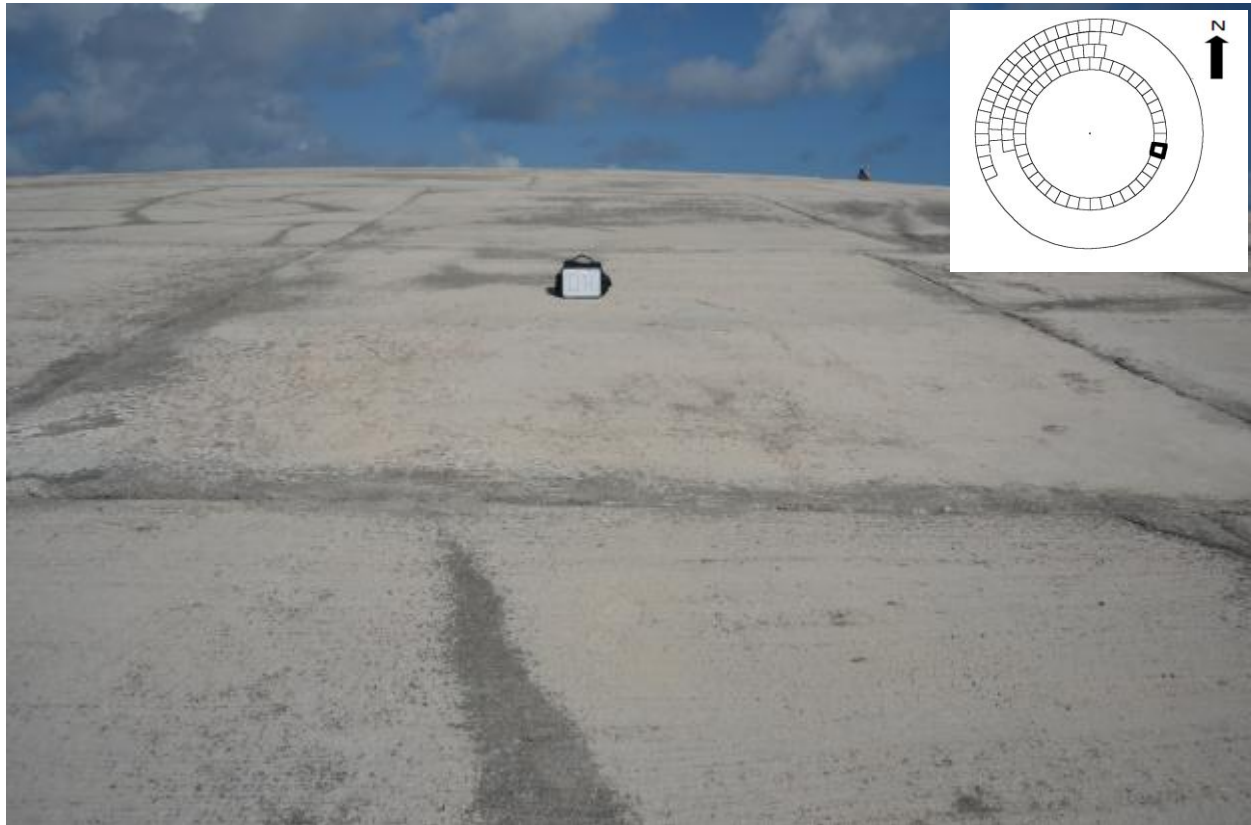
CAP SECTION LOCATION: Panel D17

No obvious interior cracks extending across the top of the panel. Some spalling/cracking of concrete observed in the bottom left corner and along lower seam adjacent to the intersecting corner between panel C21 and C22 on the left side of the panel.

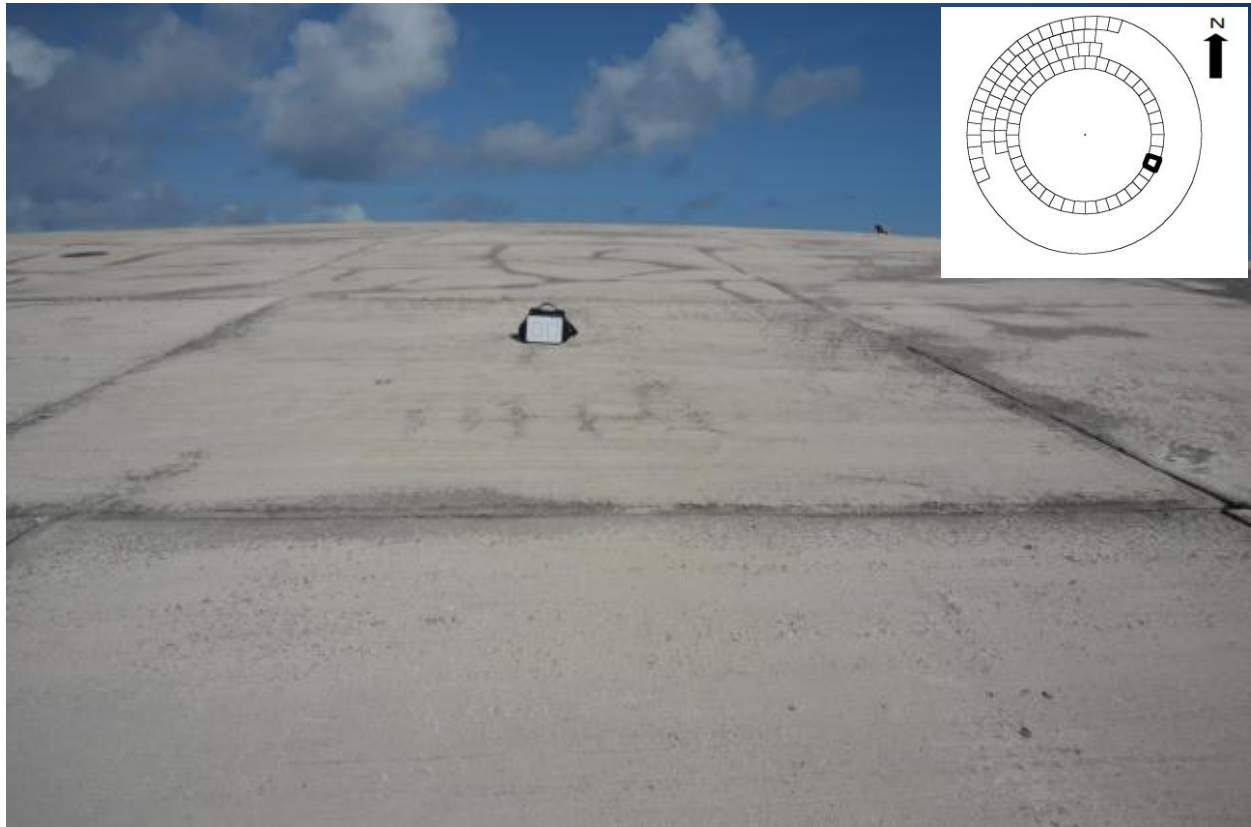
CAP SECTION LOCATION: Panel D18

No obvious interior cracks extending across the top of the panel. Some spalling/cracking of concrete observed in the right-hand corner of the panel. Panel labels D19 and D20 were skipped.

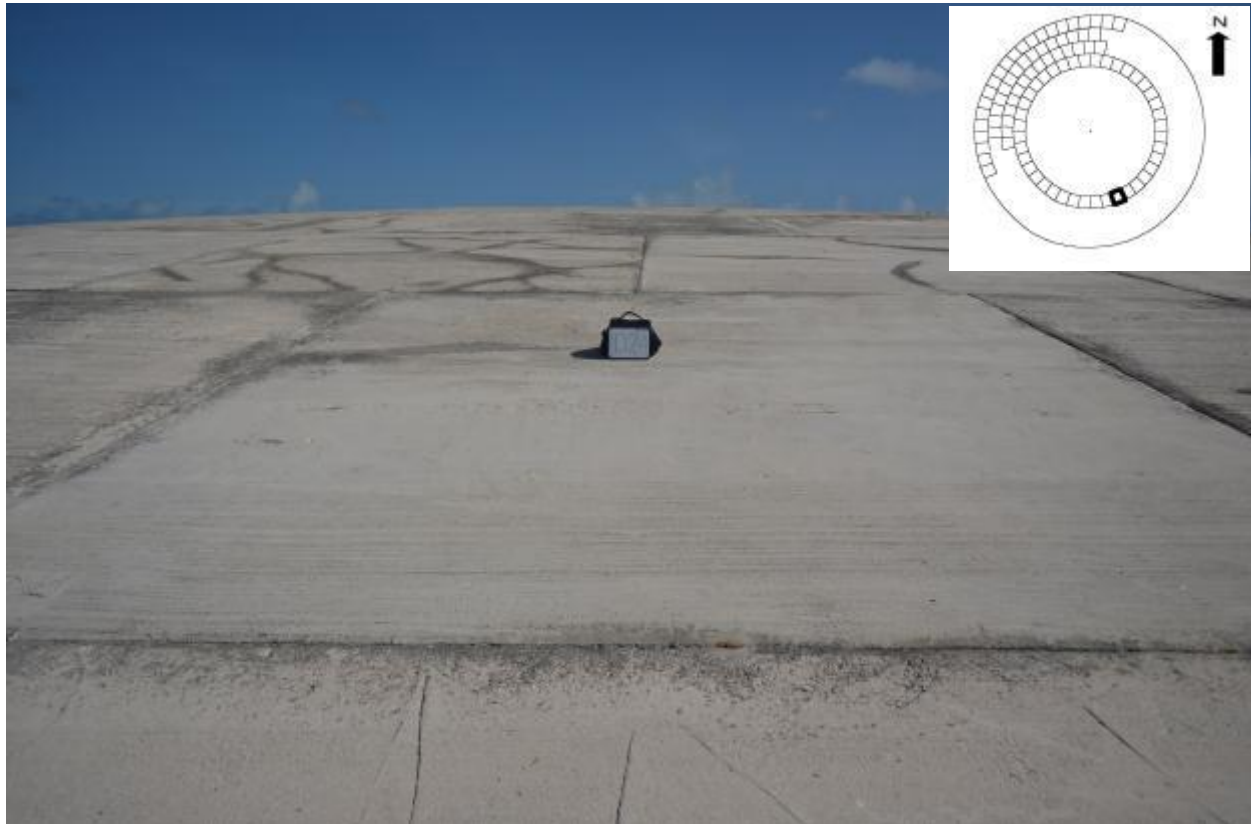
CAP SECTION LOCATION: Panel D25

No significant or obvious interior cracks extending across the top of the panel. The upper portion of the panel has a rough and weathered appearance. Rooting vegetation removed from along the panel seams.

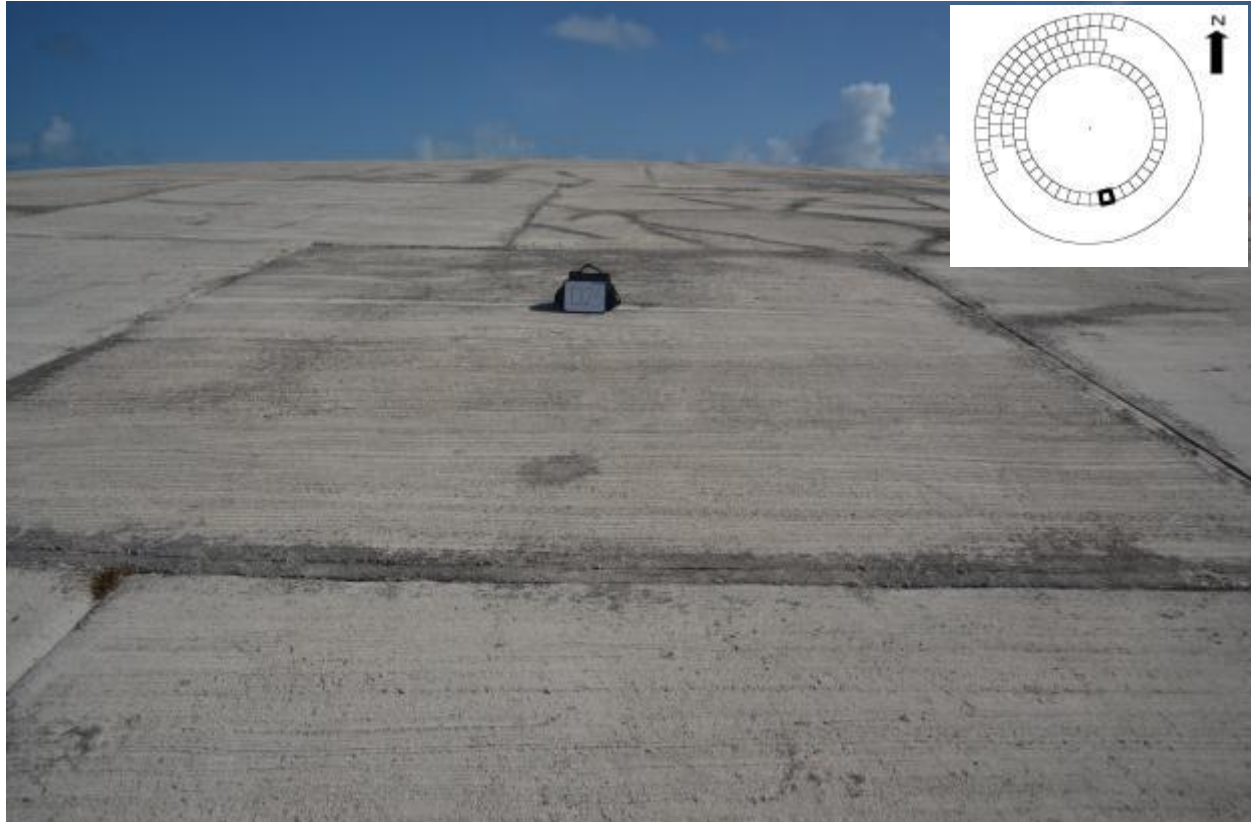
CAP SECTION LOCATION: Panel D26

A minor surface crack observed extending up from a central position adjacent to the corner intersection C29/C30 on the ring row below for a distance of about 1 meter . The panel contains a vertical elevation benchmark.

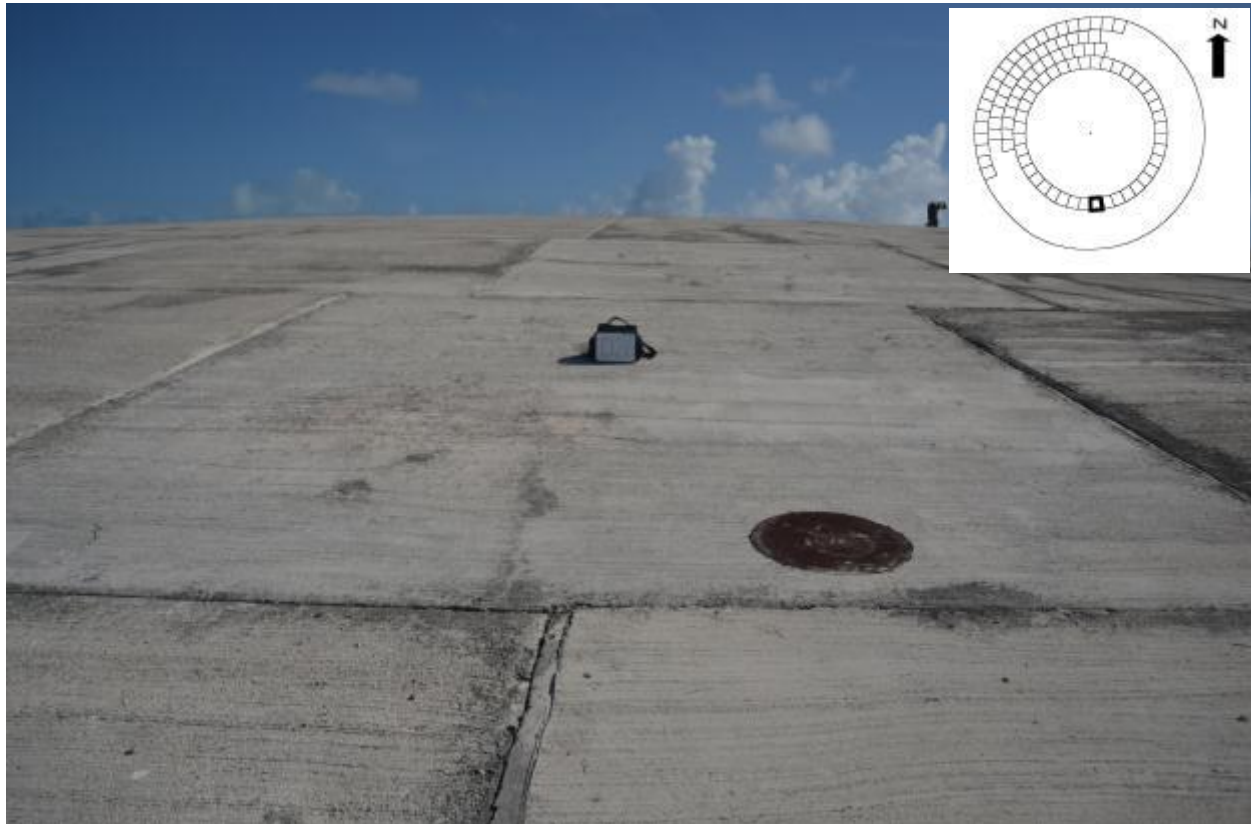
CAP SECTION LOCATION: Panel D27

The panel has a rough and weathered appearance. Some minor spalling/cracking of concrete observed along the right-hand side of the bottom seam. A surface crack observed running straight up the panel about 5 meters from a central position along the bottom seam.

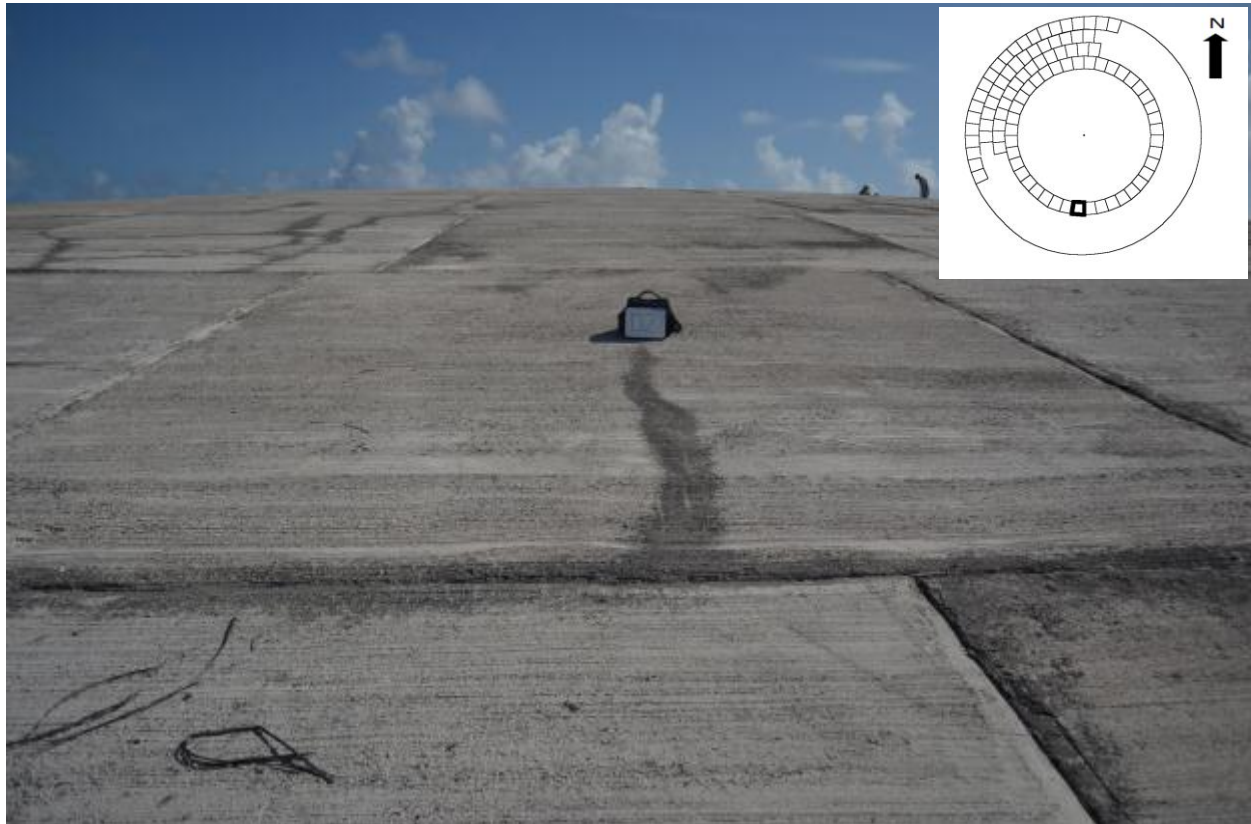
CAP SECTION LOCATION: Panel D28

No significant or obvious interior cracks extending across the top of the panel. Rooting vegetation removed from along the panel seams.
